**Product Range : Duo**

**BS EN 1176: 2008 Parts 1 to 11**

## Certificate of Compliance

## Duo Risk Assessment

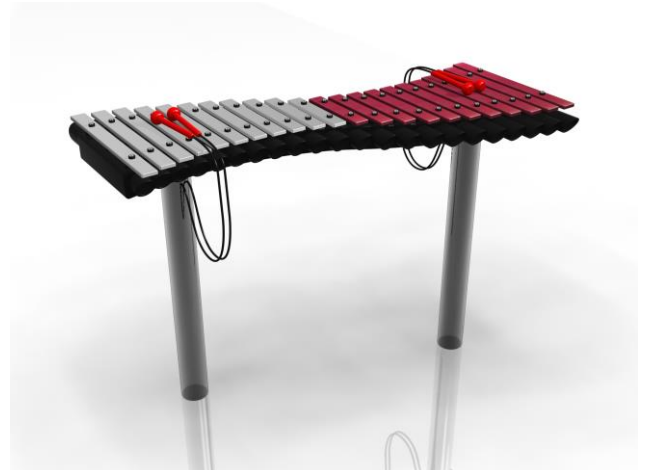
**Products Covered: Duo Besso, Duo Cupla, Duo Gemina, Duo Jumeau, Duo Kasinda and Duo Kembar.**

- Collision
- Entrapment

Collision

With all control measures applied there will still be a risk remaining of users colliding with the equipment or with other users. It is considered that this remaining risk is of no significance, or any different from similar equipment item that incorporates this type of movement.

Given the provision of the safety measures detailed the remaining risk is considered to be 1 x 2  
VERY LOW RISK

None
